# **Spot Safety Project Evaluation**

Spot Safety Project # 06-95-201

**Spot Safety Project Evaluation of the Directional Crossover Installation,  
At the Intersection of US 401-Raeford Road at SR 1546-Little Drive-Falcon Village Shopping Center  
In Fayetteville, Cumberland County**

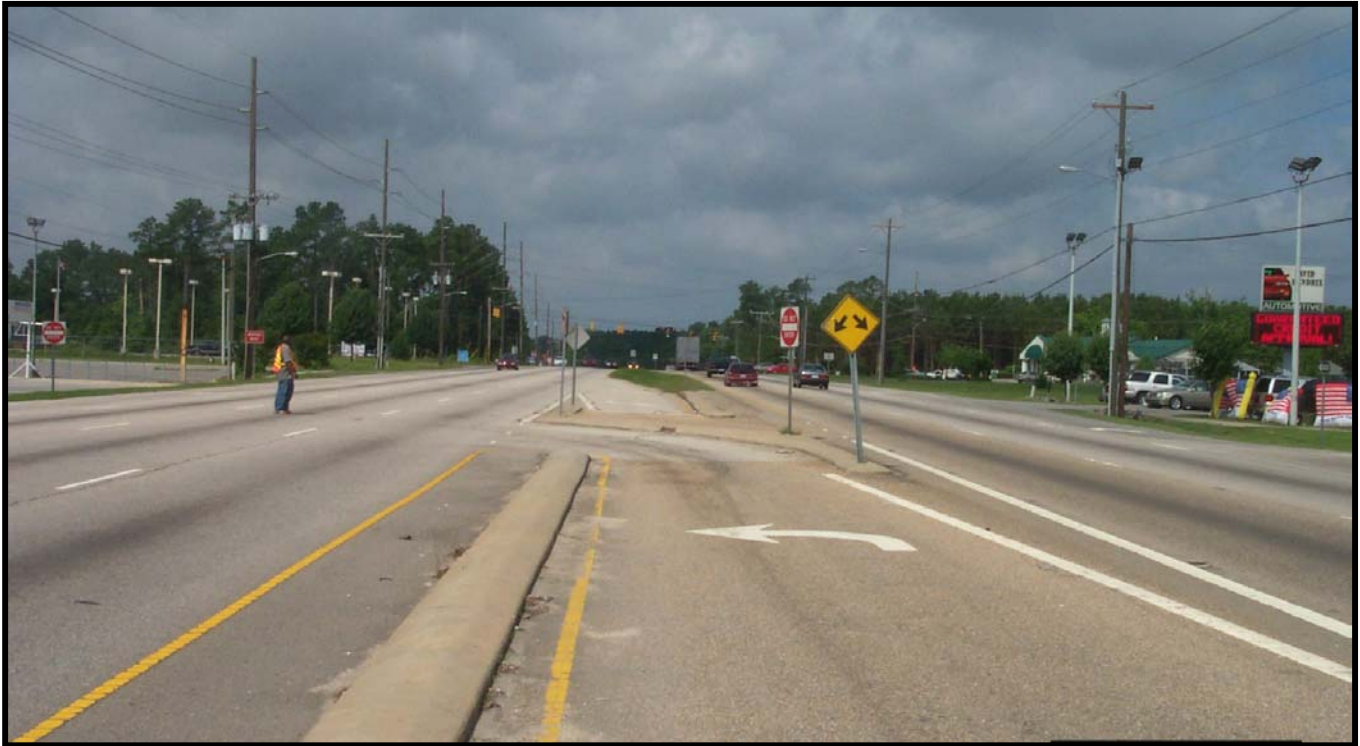
Looking west at the Treatment Location on US 401 – Raeford Road

The summary results above demonstrate that in the naive before and after analysis method the treatment location appears to have had a crash reduction in all crash types from the before to the after period. In addition, when looking at the .31-mile strip surrounding the treatment location and both surrounding signalized intersections, there is also a reduction in crashes. Please see the attached *Treatment Site Location Photos*. Photos are provided of the treatment intersection and of the surrounding signalized intersections.

Please note that during the site visit most of the businesses within the Falcon Village Shopping Center were closed and the parking lot was nearly empty. The date of the closures is unknown. This will clearly reduce the traffic volumes and possibly minimize related crash patterns at the treatment location in the after period. A car wash and a bank are still open near the Shopping Center and an apartment complex is located behind the Shopping Center. Motorists are still gaining access to these locations using the Falcon Village access road.

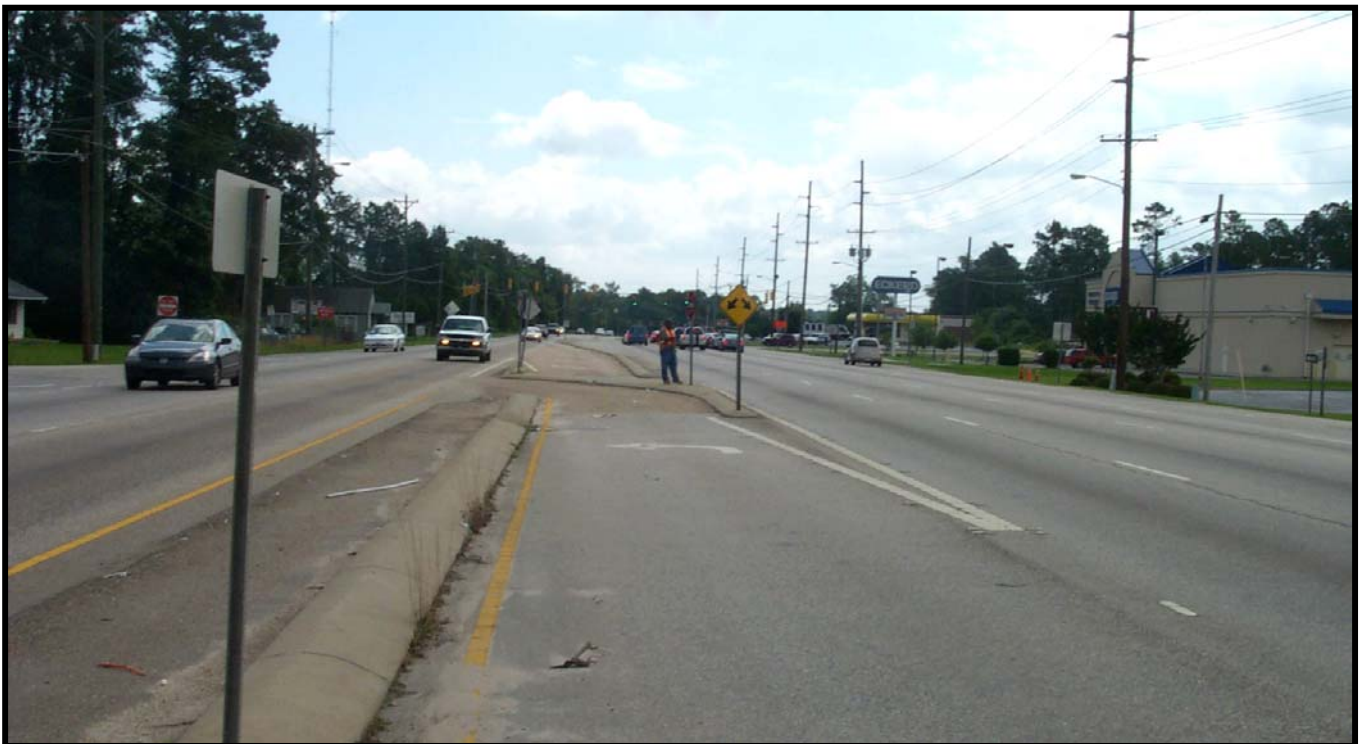
Looking east at the Treatment Location on US 401 – Raeford Road

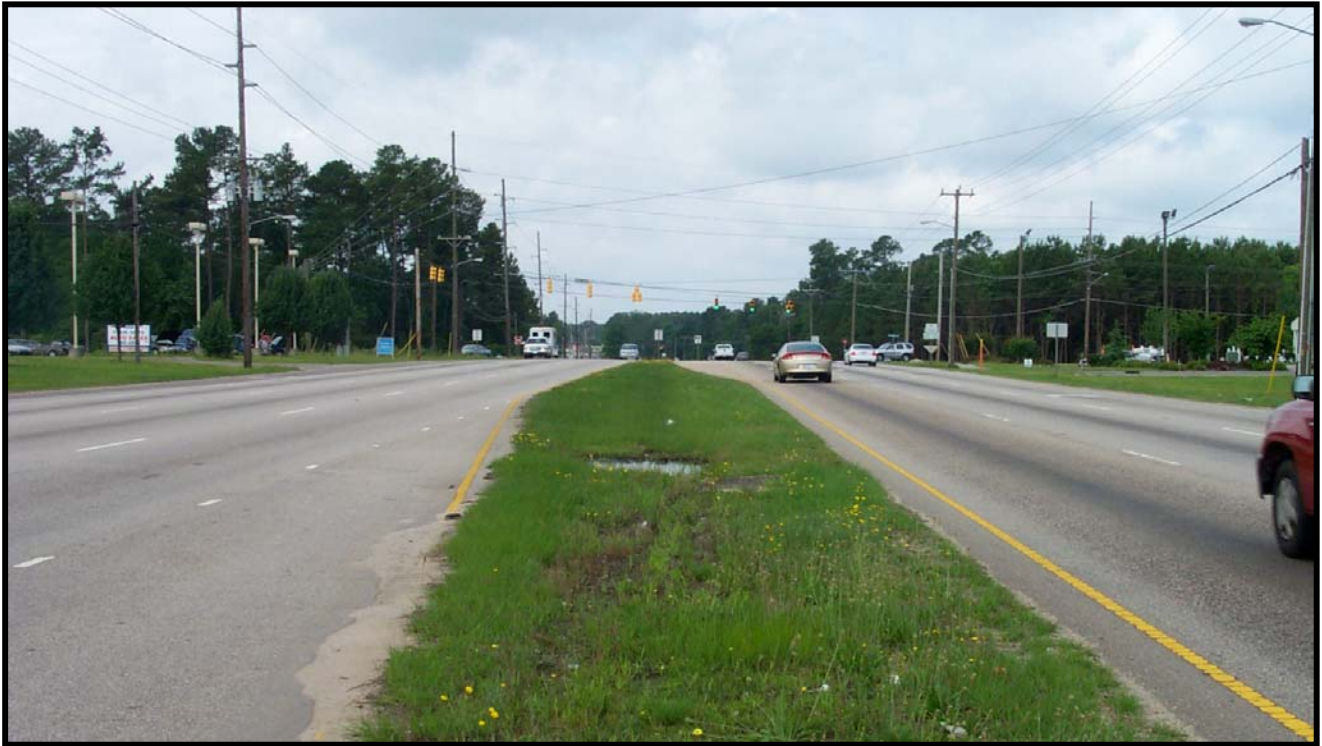
Looking west toward SR 1411-Bunce Road

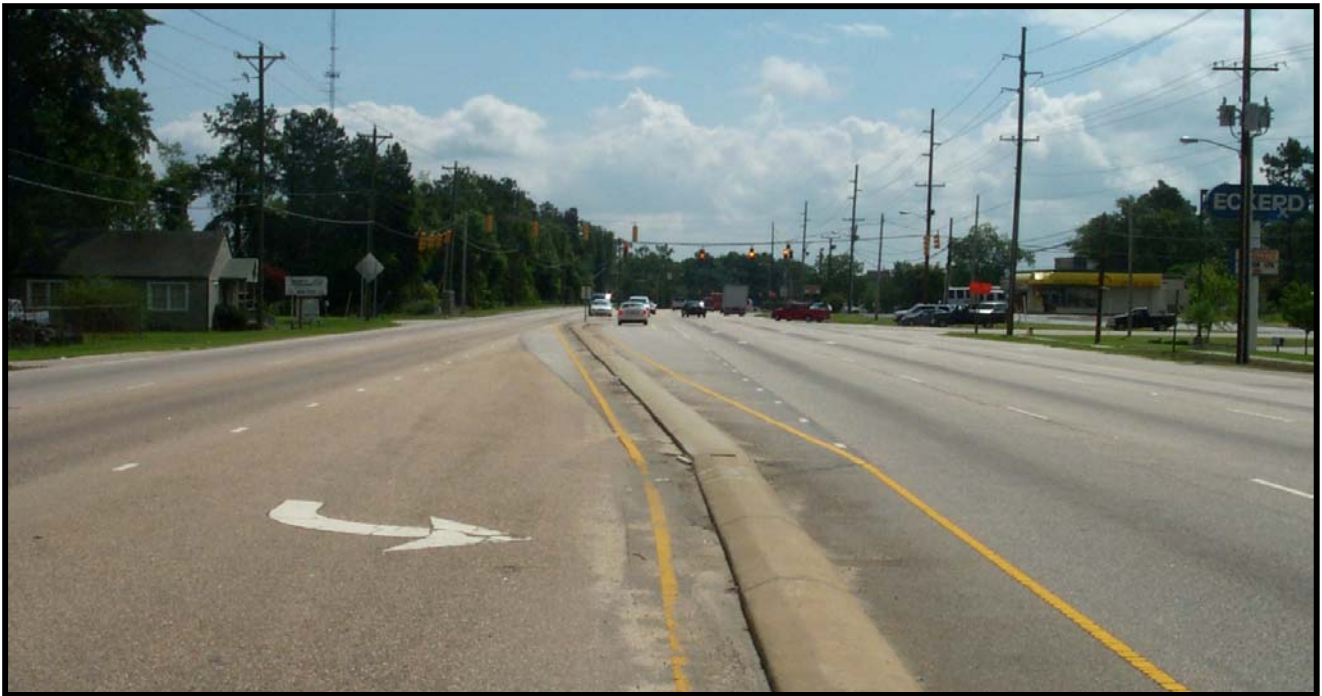
Looking east toward SR 1141-Bingham Road

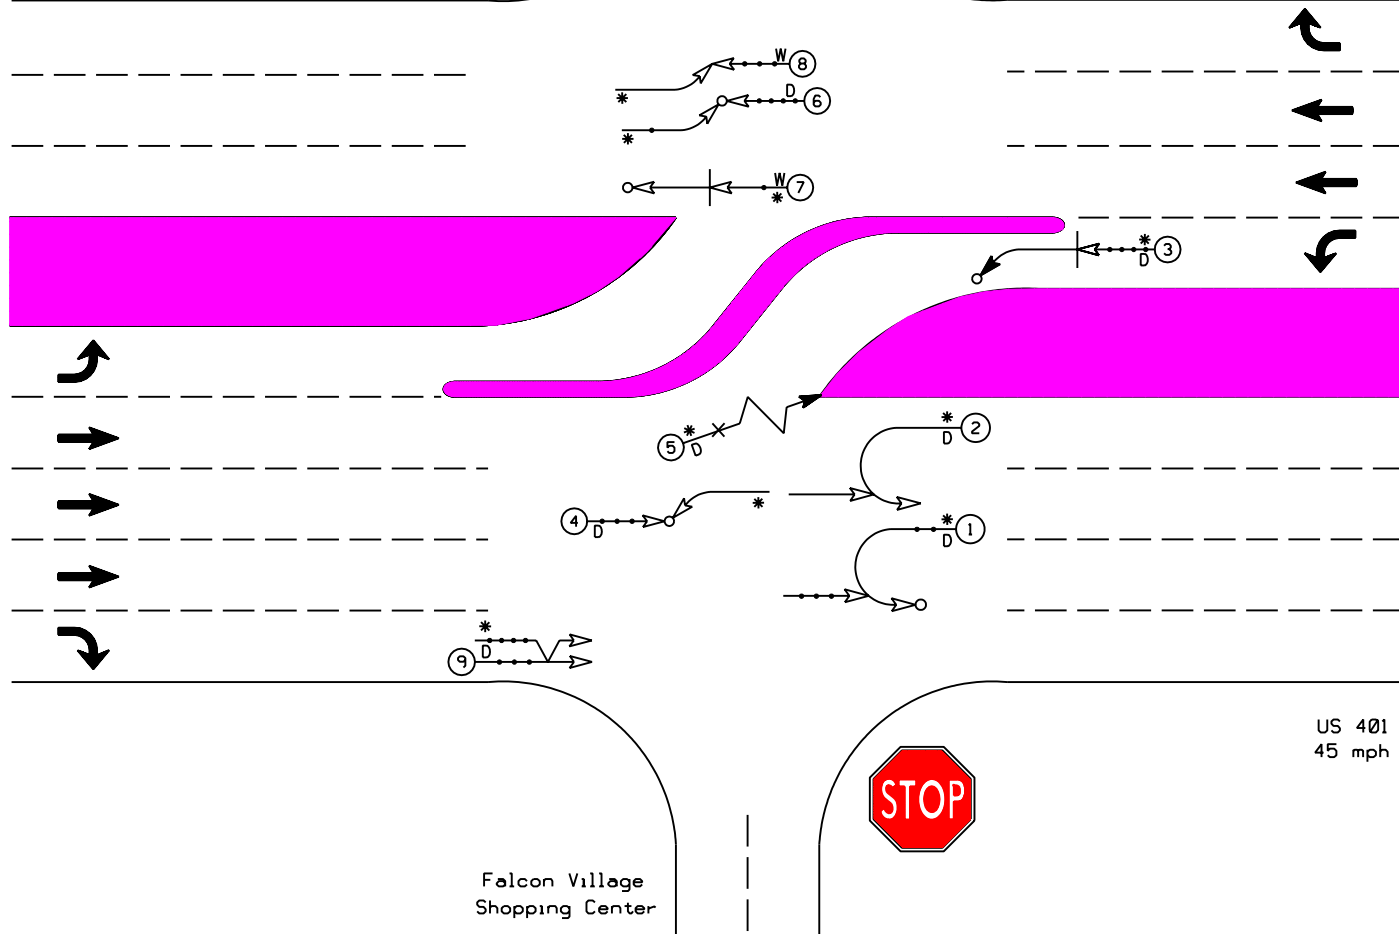
Total Crashes  
July 1, 1997 - June 30, 2004

STUDY PERIOD: 7/1/1997 - 6/30/2004
	ANALYSIS PREPARED BY: C Simpson
	DIAGRAM PREPARED BY: C Simpson
Treatment Site	SCALE: NOT TO SCALE
After Period	DATE: 8/26/2005
	LOG NUMBER: 2005000
<b>N.C. DEPARTMENT of TRANSPORTATION</b> <b>DIVISION of HIGHWAYS</b>
